JOINTS FOR LARGE DIAMETER PE100 PIPE

**David Lowe, Paul Starkey and Edward Ingham
Bodycote PDL, Manchester UK.**

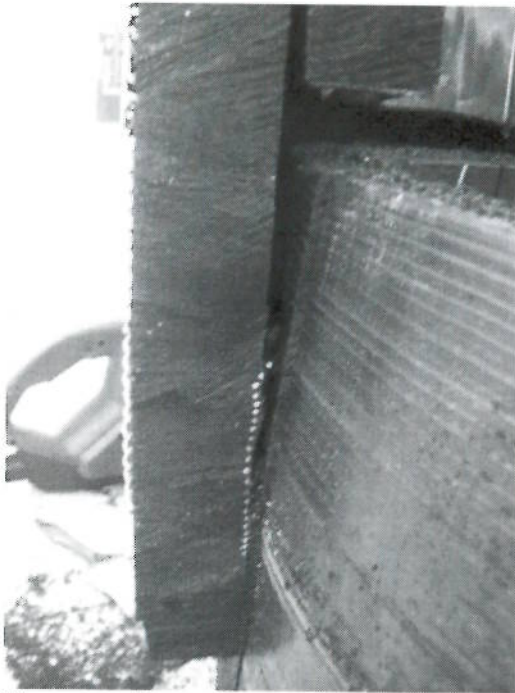
Gap caused by end reversion of pipe end

A number of photographs are provided in figure 1 that indicate some of the problem joints from these case studies. In many cases, the gap between pipe and coupler appeared to be greater than could be accommodated. In some cases this may have been due to pipe being non-standard or lack of adequate clamping, but in some cases the size of the region affected by reversion at the end of the pipe also appeared to be a factor.

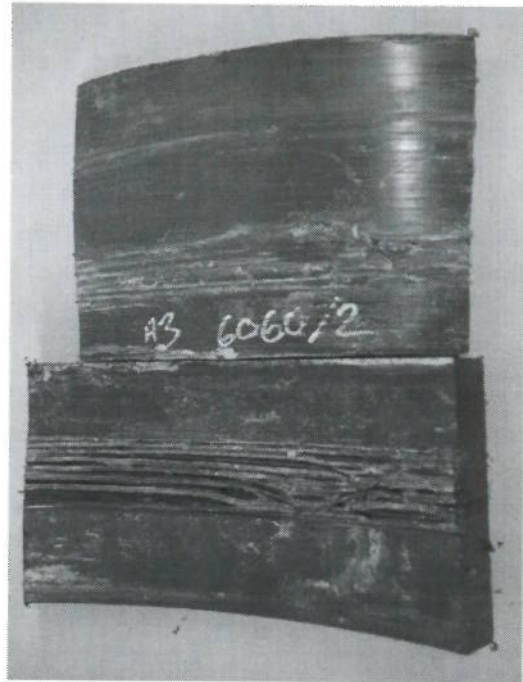
Excessive wire movement caused by gap between pipe and coupler due to ineffective clamping

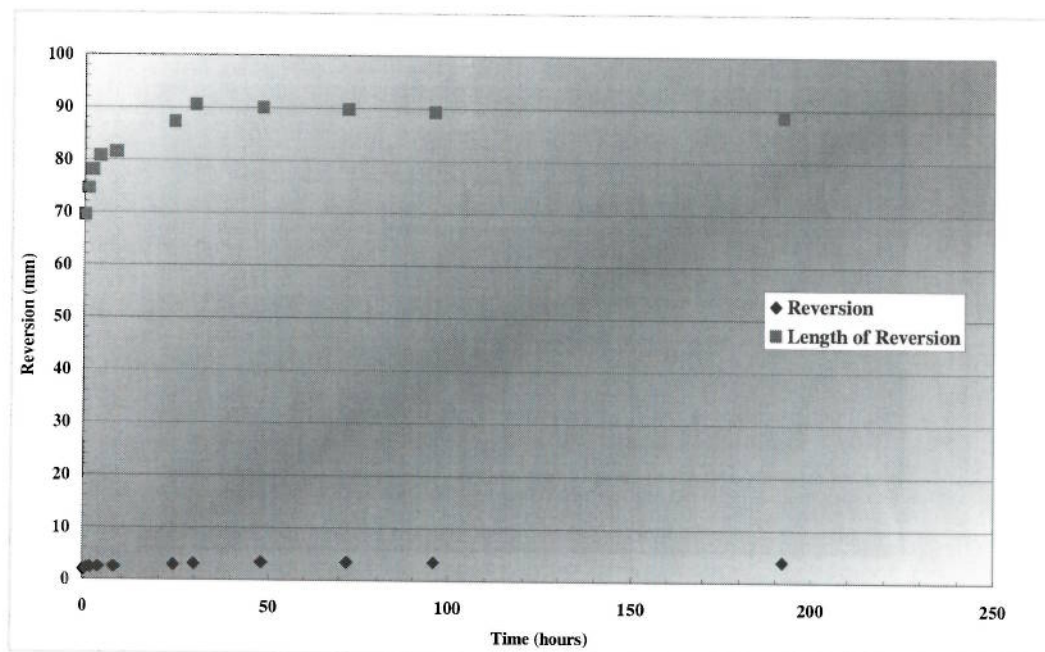
Figure 3: Change in End Reversion with Time for 500mm SDR 17 Pipe at 23°C

Reversion is generally expected to occur at the end of PE pipe and involves a local reduction in diameter when the pipe is cut as shown in figure 2. This can result in gaps between the pipe and EF coupler if reversion coincides with the fusion zone. Bodycote PDL has conducted a number of measurements on various pipe sizes and established that approximately 50% of reversion occurs instantaneously, with the remainder increasing with time after cutting (figure 3). It was also observed that reversion increases with pipe diameter (figure 4). With gaps above 5mm due to reversion, this is clearly likely to be an issue in design of large diameter EF couplers.

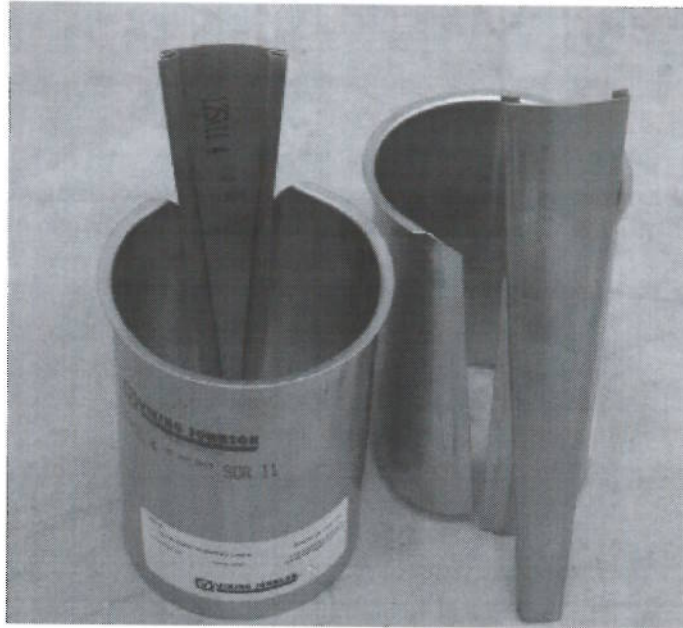
VJ also manufactures liners with wedge shaped actuators that may be useful in providing internal support to pipe and assist in producing better quality EF joints (figure 6)

Figure 6: Liners with Wedge Shaped Actuators from Viking Johnson
